UPDATE

Spring 2011

Published by Lycott Environmental, Inc. 600 Charlton St., Southbridge, MA 01550 508-765-0101 • 800-462-8211 www.lycott.com

Lake Fairlee – the next chapter in a continuing effort of management

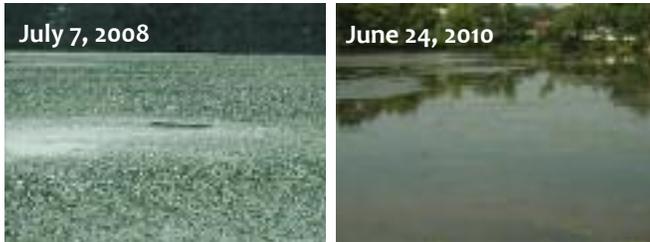
Pre-harvest survey pictures depict the diminishing degree of plant coverage.

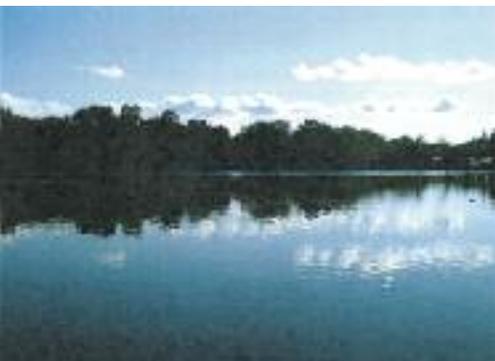
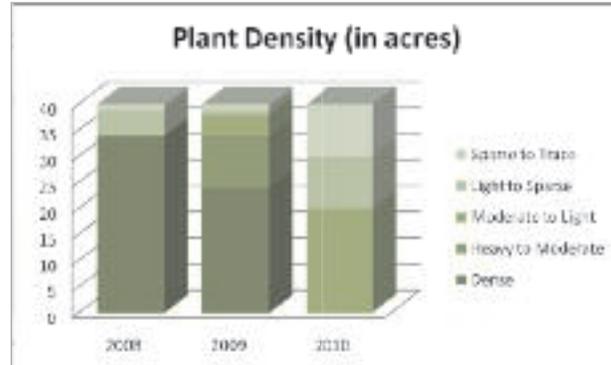
Change in Water Chestnut plant density over the three seasons recorded during the pre-harvest surveys.

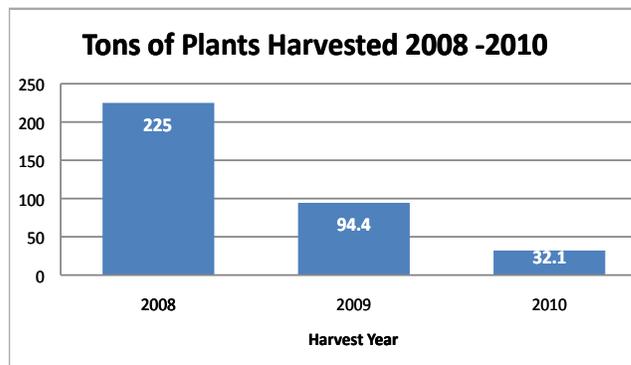
Water Chestnut plant tonnage removed and incinerated. An 86% reduction in vegetation tonnage was achieved after three harvesting seasons.

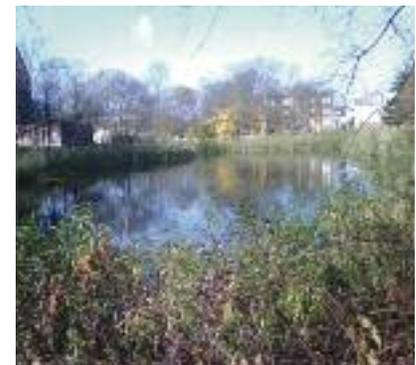
Before Common Reed Management

In September of 2010, Lycott performed an aquatic vegetation survey and wildlife habitat survey in preparation for a Notice of Intent to manage the pond. Once a valid Order of Conditions was obtained in October, a herbicide treatment utilizing a low pressure tracked amphibious vehicle with a spray tower was employed to treat the Common Reed along the entire shoreline. In late December of 2010 and January of 2011 the Common Reed was cut utilizing commercial brush cutters and then collected for disposal. Treatment of the in water aquatic vegetation, spot treatment of the surviving common reed along the

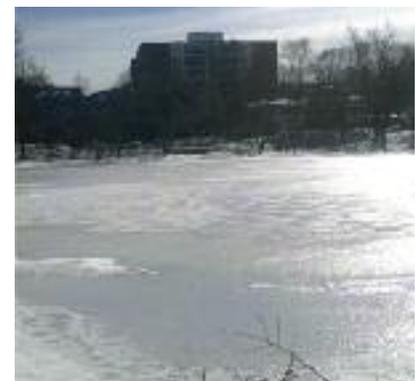
After Treatment and Removal

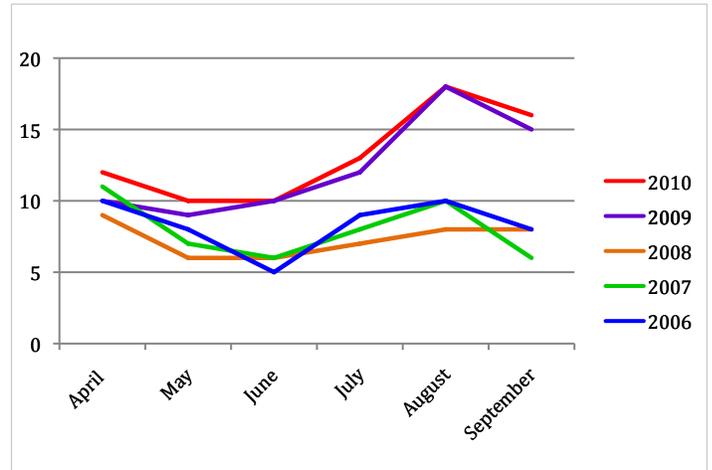
Hypothetical total phosphorus (TP) results from a single site, 2006-2010. These results show a clear trend of TP falling between 5 and 11 ppb during 2006-2008, with elevated levels generally found in April and August. Since the results at this location were consistent during the first three years of sampling, higher levels reported in 2009 and 2010 are easily identified.

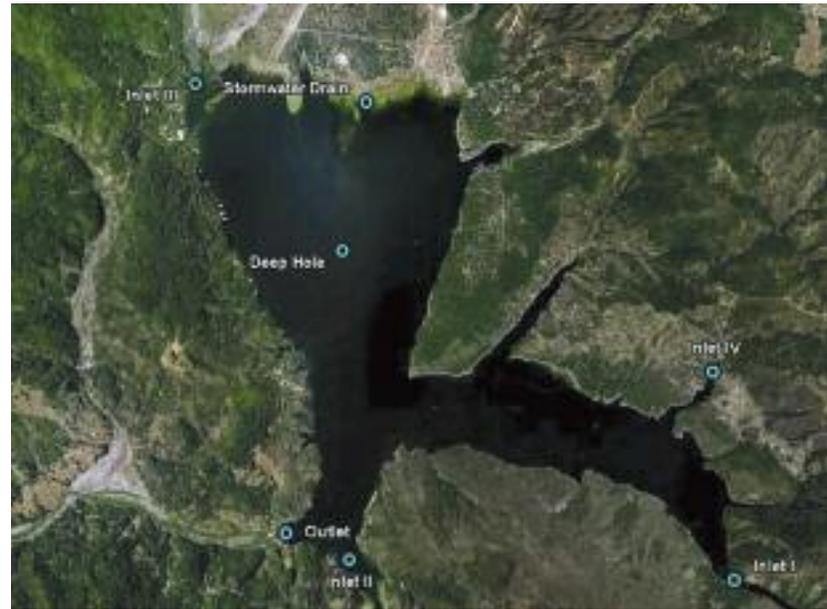
Hypothetical lake sampling locations: This lake has several large inlets which should be sampled on a regular basis. An airport with a storm water drain which enters into the lake is located to the north. Algae blooms are occasionally observed in the vicinity of the pipe, making this a prime sample location. The lake's outlet and deep hole should also be sampled to create a temperature and dissolved oxygen profile of this 40 ft. deep lake.

The number and positioning of sampling locations is often dictated by the size, shape, location, and source(s) of the water body. Typically, each inlet stream is sampled where it enters the lake or pond, in addition to the 'deep hole' (deepest part of the water body) and often the outlet. Results of samples collected at inlet locations allow for identification of pollutants with sources upstream, while deep hole and other in-lake locations provide insight into the water body's trophic status.
