FINAL REPORT FOR YEAR ONE OF
EURASIAN MILFOIL MANAGEMENT
LAKE FAIRLEE
FAIRLEE, WEST FAIRLEE & THETFORD
VERMONT
2010

PROPOSAL/CONTRACT # 248-10

SUBMITTED: October 25, 2010

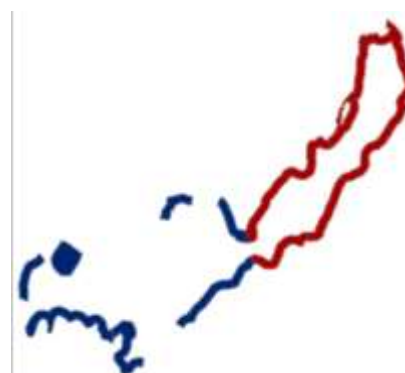
Figure 1: Treatment Areas

Renovate OTF[®] was selected as the most appropriate herbicide for use in Lake Fairlee for several reasons including its ability to be used in distinct areas for spot-treatments. Application rates of 1.5 and 2 parts per million (ppm) were used in the north and south sections of the lake, respectively, based on hydrologic conditions and plant growth (Figure 1).

E. Milfoil Density	Pounds of Renovate per acre	Target Concentration
Trace to Sparse	162	1.5 ppm
Moderate to Dense or areas of higher dilution potential	216	2.0 ppm

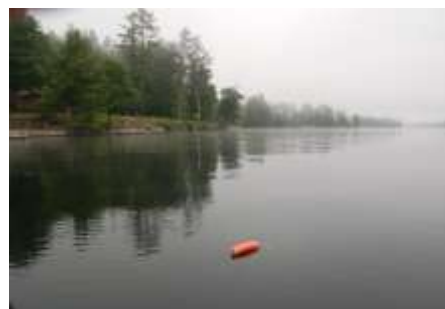
Figure 2: Buoy Marking Treatment Area

Prior to treatment, buoys were placed along the treatment areas to provide visual aide for treatment personnel and observers. These buoys marked the ‘no treatment areas’ as well as treatment areas requiring different concentrations and herbicide formulations (Figure 2). In addition to these on-the-water aides, each treatment team used a GPS unit with treatment areas uploaded as tracks (Figure 3). While working within these treatment areas, applicators also recorded their treatment paths as herbicide was dispersed.

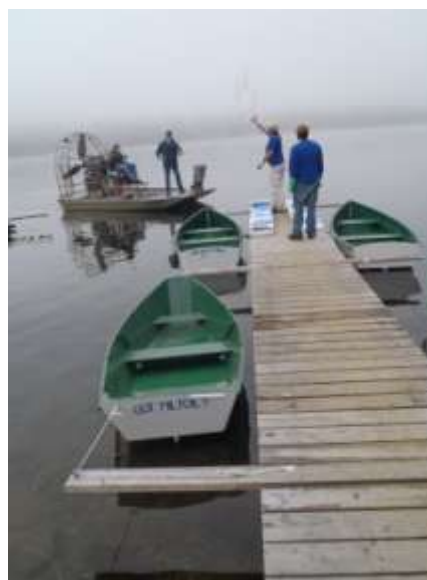
Figure 4: Base of Operations

Treatments were conducted by licensed Lycott staff utilizing two air boats and a pontoon boat, allowing for completion of the treatment in one day. A systematic loading of the boats from the base of operations allowed all material in a given load to be dispersed in a single treatment area (Figure 4).

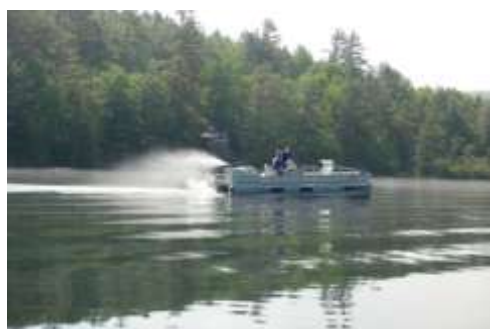
Figure 5: Pontoon boat utilizing an educator to disperse Renovate

Renovate was dispersed throughout the treatment area with the use of two electrically operated Herd spreaders, each mounted on the bow of an airboat, while the pontoon boat used an educator system designed to disperse the herbicide with a stream of water drawn from the lake. A final treatment map including herbicide concentrations and amounts is included with this report.

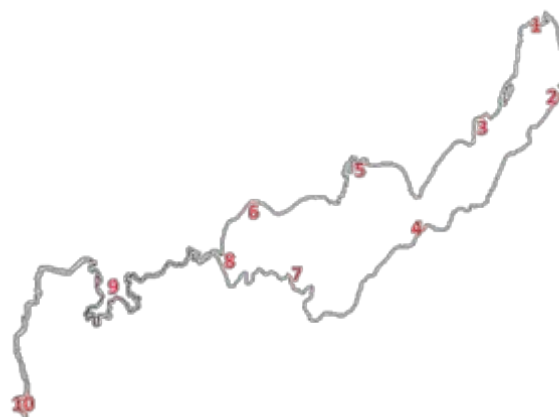
Figure 6: Sample Sites 1 – 10

A sampling program was initiated on the treatment day, with one sample taken just prior to treatment at Site 1 (Figure 6). On June 3, 2010, four representatives of the Association were trained in the proper use of a VanDorn sample bottle and proper protocols for sample collections per the SePro “Sampling Collection Procedures for FasTEST” document. Subsequent samples were collected by the Association in accordance with the permit. Following initial test results, water use restrictions were extended downstream and an additional sample site, Site 10, was added to the testing protocol.

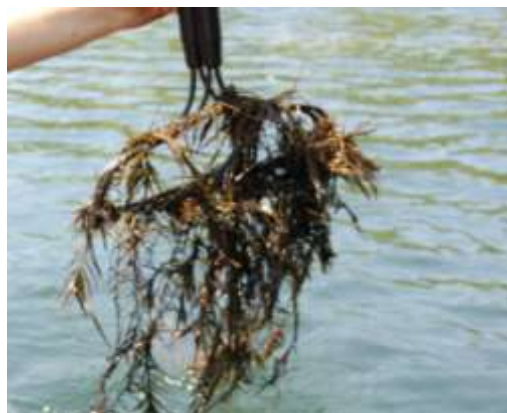
Figure 7: Fern-Leaf Pondweed

A total of seventeen (17) species of rooted aquatic macrophytes were identified at the time of the evaluation. Tape Grass (*Vallisneria americana*) was the most prevalent species, occurring at 26% of the points surveyed, followed closely by Fern-Leaf Pondweed (*Potamogeton robbinsii*, Figure 7), and Stonewort (*Nitella*), occurring with greater than 20% frequency. No growth of E. Milfoil was found at any of the survey points.

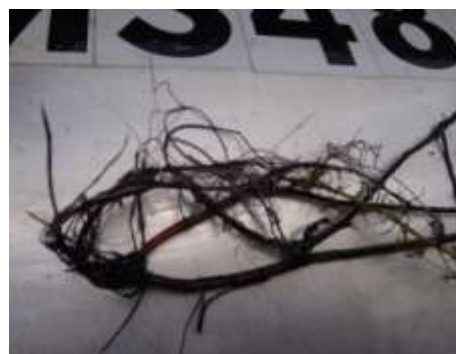
Figure 8: E. Milfoil Post-Treatment

E. Milfoil was not detected during the point survey. Diver surveys were conducted at four (4) locations where E. Milfoil beds were observed and treated in the spring of 2010. While the majority of E. Milfoil plants remaining were only brown stalks with dead and decaying rootballs, several plants which appeared dead (brown stalks), were starting to send out new sprouts (Figure 8). This growth was only observed at one location in the lake at an approximate depth of eighteen (18) feet. With the exception of this location, no E. Milfoil was observed at the twelve (12) dive locations.

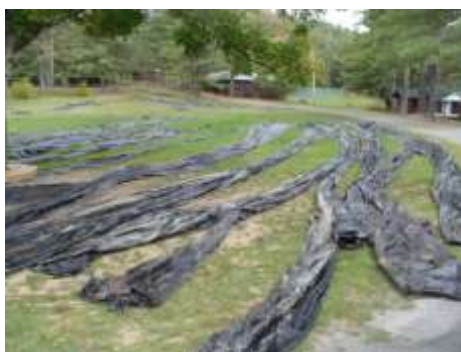
Figure 9: Barrier Removal

As a condition of the Permit, all previously installed benthic barriers were removed by Lycott divers and staff. This was completed and the materials (barrier and ballast) were placed on shore for storage. In the event that future management methods include benthic barrier material, much of the previously installed material can be re-used (Figure 9).

During the barrier removal divers again surveyed the lake finding only about fifteen (15) plants which were hand-harvested. These plants showed significant deterioration based on the initial treatment; however, some nominal re-growth was present. In consultation with the SePro Aquatic Specialist, Sarah Miller, it was determined that these plants likely would have perished during the winter if left un-harvested.
